LAKE MARBURG

INVENTORY NUMBER NDS PA-869

PHASE I INSPECTION REPORT

NATIONAL DAM INSPECTION PROGRAM

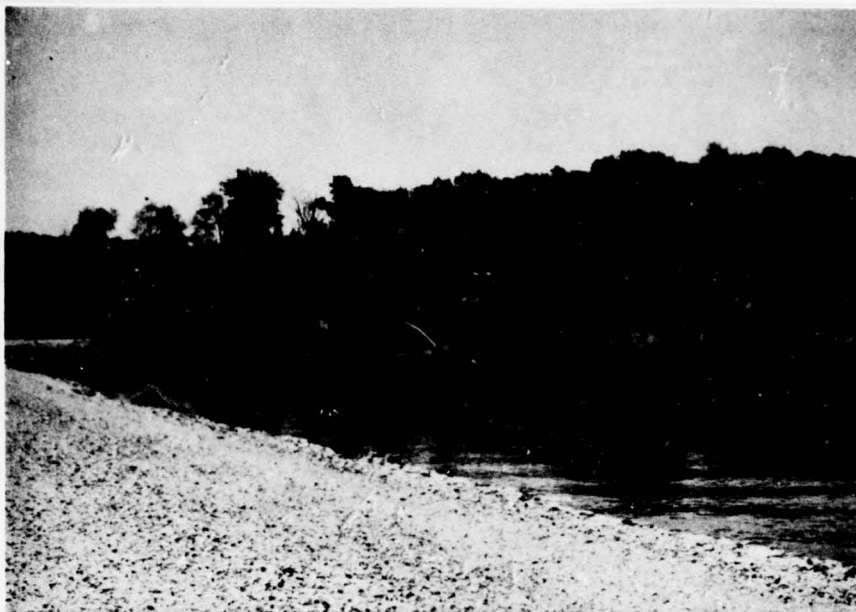
The entire spillway facility is in excellent condition. The mechanical gates and their controls are painted and well maintained. The gates were operated for inspection observations.

Upstream View
Of Spillway

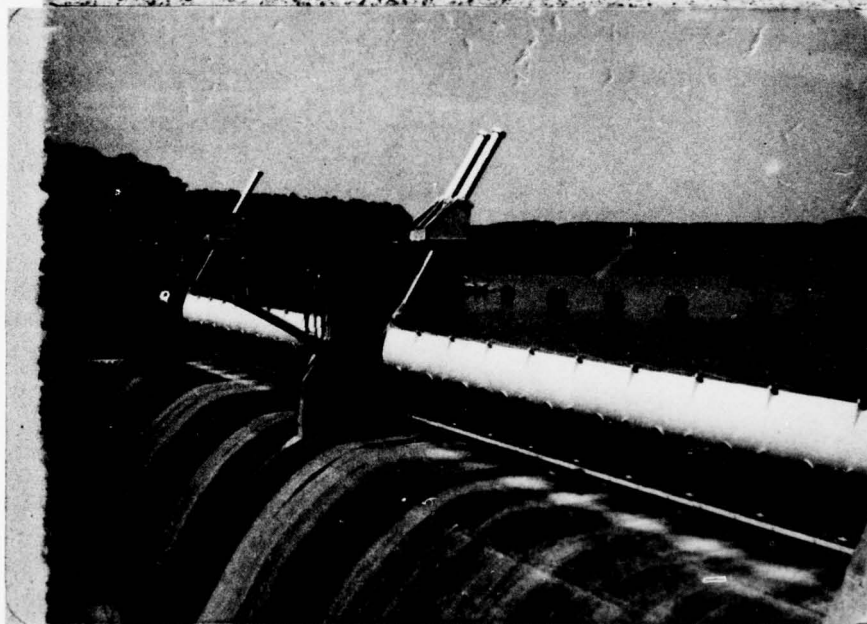
The automatic gates have two back-up features which should make it reasonably certain that they will operate during a flood event. On the other hand, it is possible for any automatic device to fail. For this reason, it is recommended that a qualified operator be on duty at the dam during any future major flood event. At the time of the June 1972 flood, the gates were unattended.

Bascule Gates

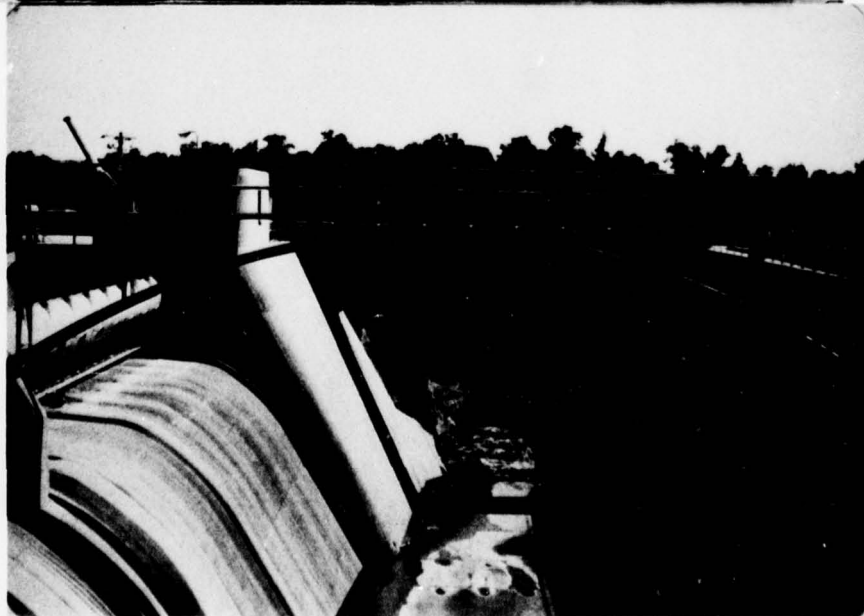
The spillway channel is a side channel of concrete walls and slabs. These were observed to be in good condition. Two bridges cross the spillway channel; one, a roadway bridge leading directly from

Spillway Chute

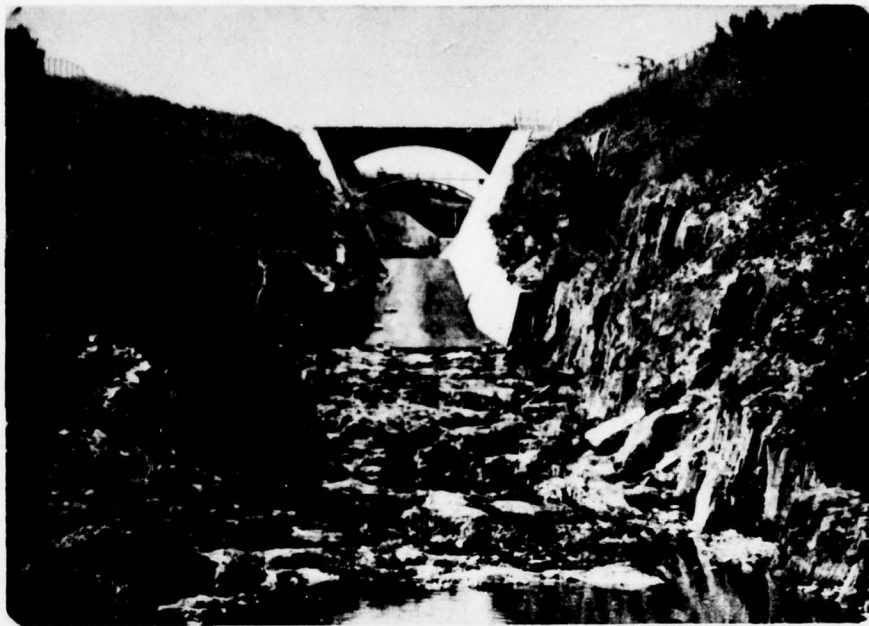
the top of the embankment to the right side of the spillway channel and the other, leading from the right wall of the channel to the pier between the two bascule gates. Both are in good condition.

Spillway Chute & Bridge

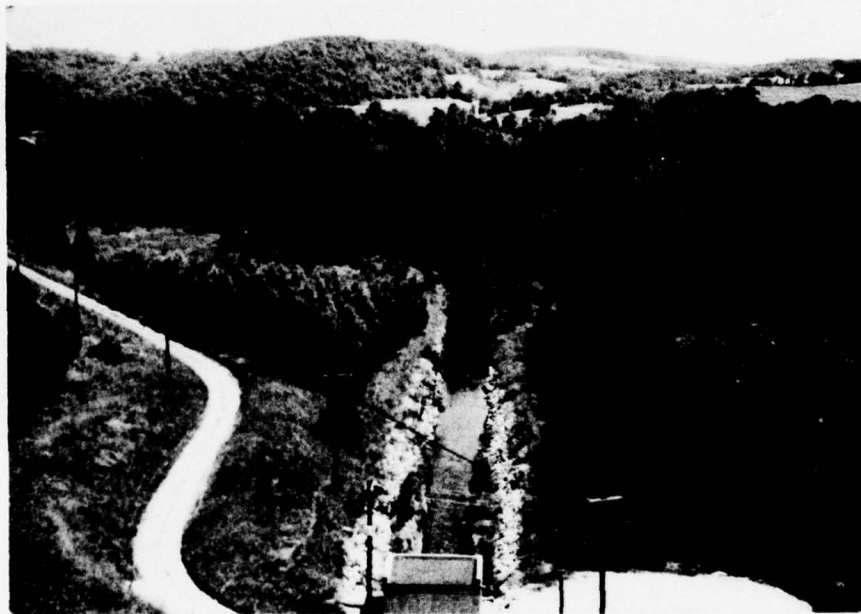
Outlet Channel

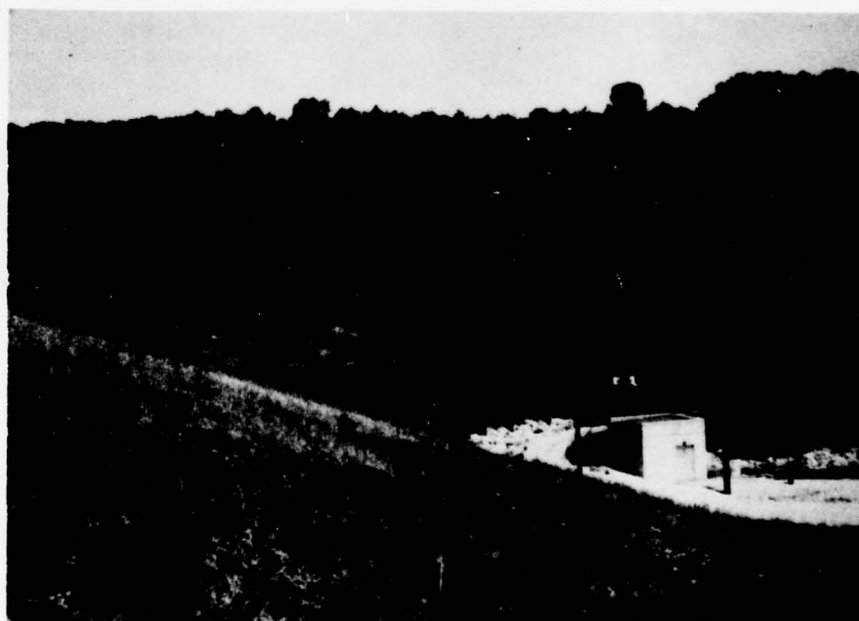
The downstream slope is covered with a heavy grass mat with some patches of flowers and an occasional small bush. Inspection of the slope did not reveal any signs of seepage on the slope or along the toe. Sloughs, cracks, or erosion were not detected in any area.

Downstream Slope
